What Do You Do When You Find A 500 Year Old Ship?

John Buziak, Critical Path Mechanics, LC

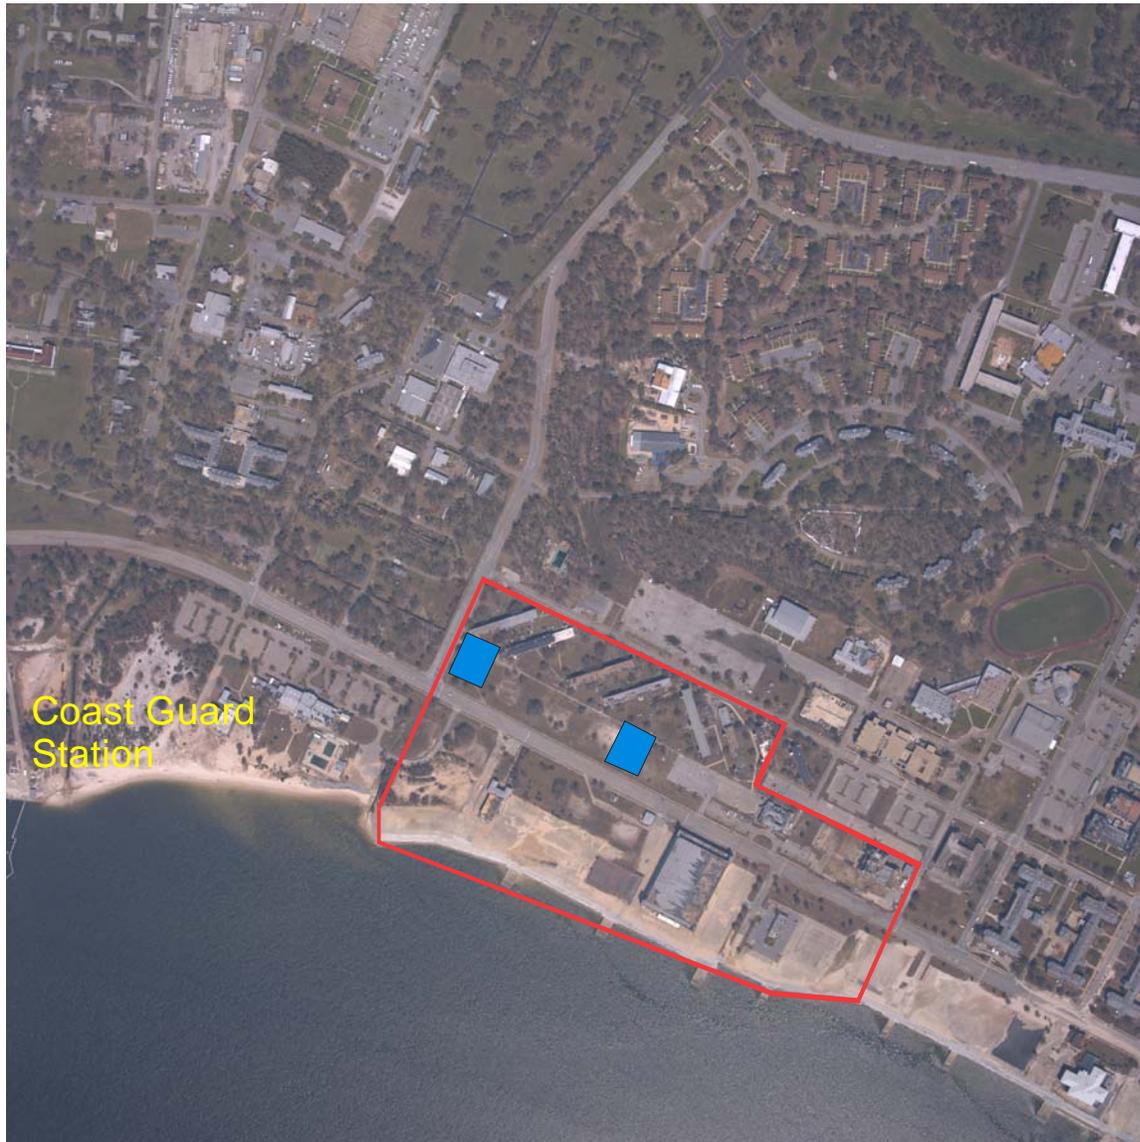
Figure 2 NOAA Satellite Imagery annotated by the author.

Figure 2 illustrates a microcosm of the damage sustained around the Pensacola area. This image has not been corrected for the angle of the satellite, as the coast line in this area follows a more east-west axis than depicted in the image. The Coast Guard Station at the extreme left edge of the figure is strategically located to have a panoramic view of The Cut. The red outlined area in the figure is located less than a half mile from the Coast Guard Station. While the storm surge at least had to top the barrier islands in most sections, in this area it poured through The Cut unabated. The buildings enclosed in the red box included the base McDonalds Restaurant, Gasolino's All Hands Club, a de-commissioned power plant, the Physical Fitness Center and five 1970's vintage three storey barracks buildings. None had any historical value and only minimal sentimental value in the case of Gasolino's. These buildings were among the first to be demolished, with little discussion or remorse.

The blue filled boxes in Figure 2 indicate the approximate location of two of the buildings under the contract. The new buildings would have steel structure with a pre-cast concrete shell. This building system performed quite well in the area around Port Charlotte during Hurricane Charlie. The western box shows the location of the ARSS and eastern box depicts the location of the new fitness center. The replacement buildings for the lost housing stock would be moved to higher ground and further inland.

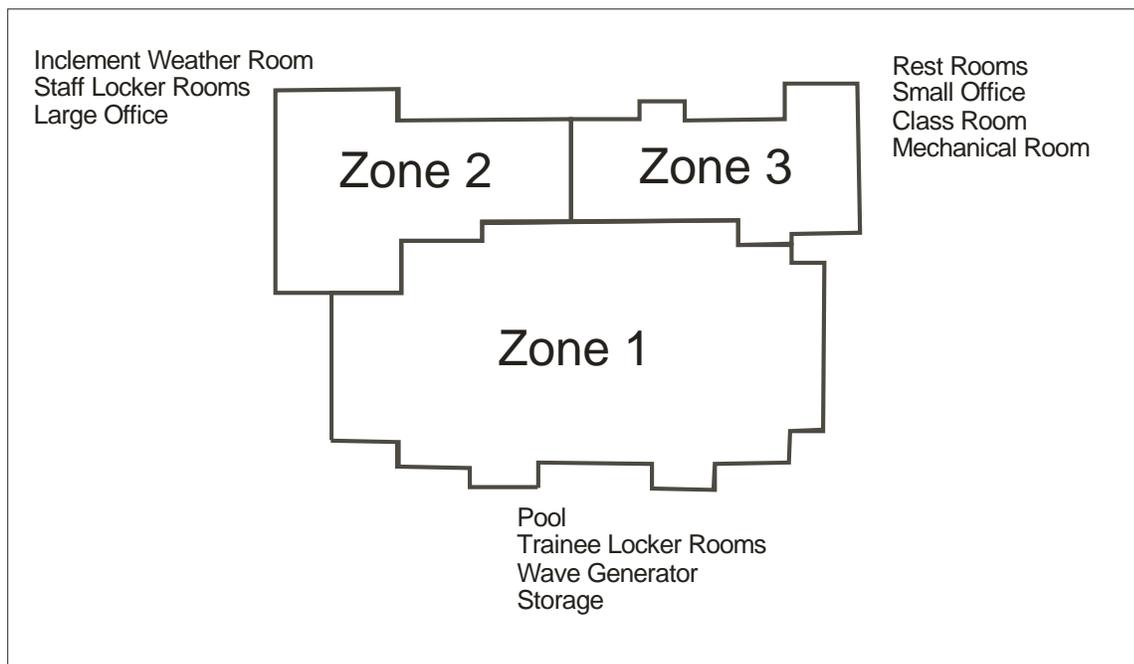
Figure 3 ARSS Key Plan

For planning and execution purposes the ARSS design was broken in to three zones as depicted in Figure 3. The pool in Zone 1 is exceptional in both its dimensions and its accessories. The depth of the pool would require excavations to a depth in excess of 20 feet to form and pour the floor of the pool. The pool also includes wave generators which require very large bore pipe feeding diffusers in the pool. These features dictated that the construction sequence would start with Zone 1's foundation walls. The manner in which the pre-cast panels interconnected influenced the remainder of the construction sequence completing footings for Zone 2 and then Zone 3.

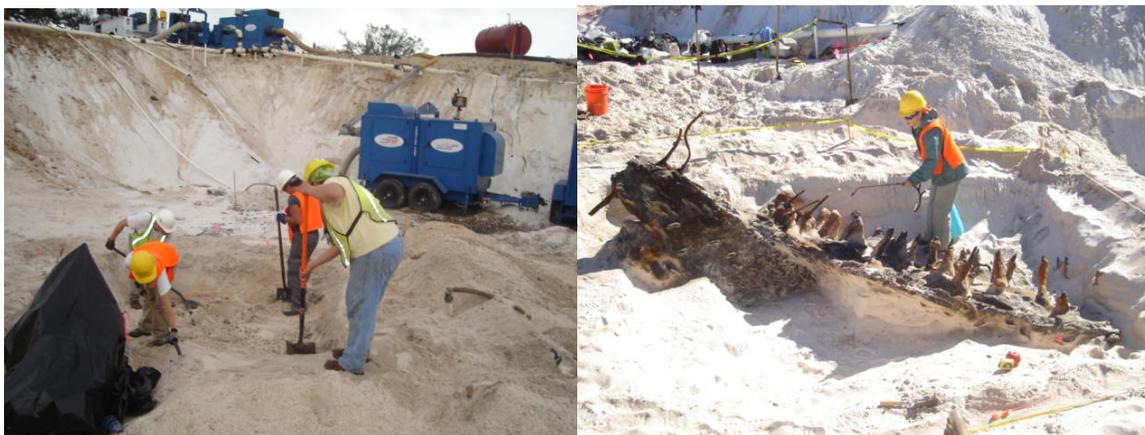
Figure 4 Hand Excavation at the time of discovery, photos Courtesy of Dick Corporation.

By the first week in March the issues relating to the dumping of the over flow in to the storm drains had been resolved and the excavation had reached the depth where the contractor shifted to hand excavation. Almost immediately an object of extreme interest was uncovered.

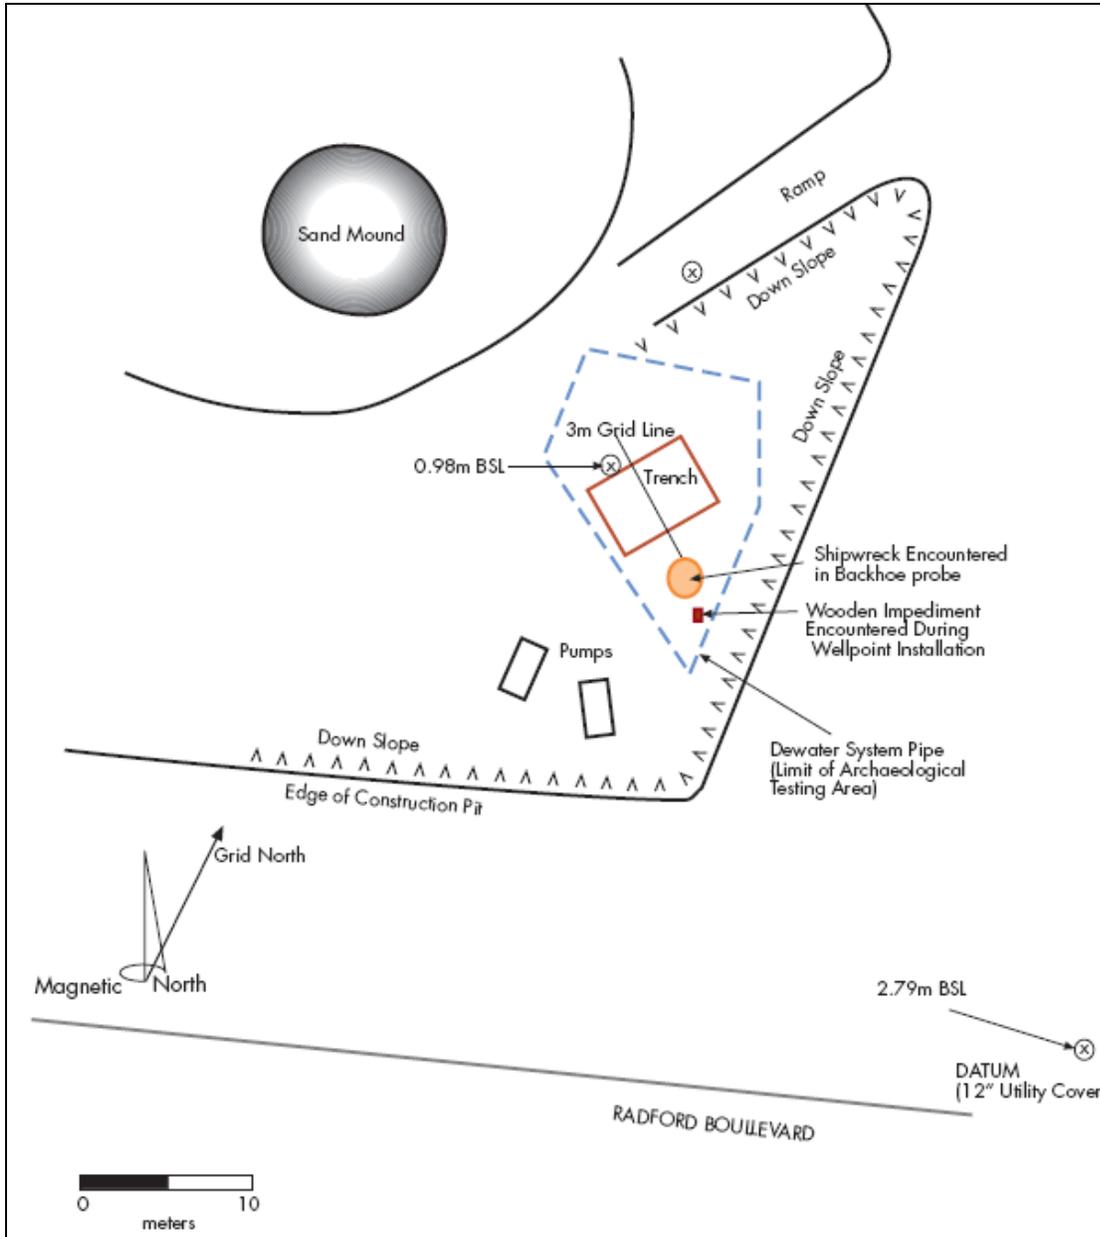
Figure 5 Plan View of Test Area from “Phase II Historical and Archaeological Investigations of a Shipwreck Site (8ES2940), ARSS Training Site, NAS Pensacola,” New South Associates, September 1,2006.

Figure 5 shows the layout of the site. It did not take long for the Navy to recognize they were not going to be able to finish the building on this site, issuing a stop work order on 14 March (Activity #I005040, in Exhibit #2). While many issues relating to the final disposition of the site remained to be resolved the Navy issued a Request for Proposal (RFP) to re-locate the building (Activity #I005050 in Exhibit #2). The day after issuing the RFP they directed the site of the wreck be covered with the sand from the excavation, based on the recommendation of the archeologists. The investigation would eventually confirm that the wreck extends southeast, nearly to Radford Blvd. In order to advance this “dig” would require a significant engineering effort that would include a de-watering plan to take excavation below 20 feet, and a civil plan to re-route traffic on Radford Blvd, or stabilize the south boundary in some manner to go down another ten feet without maintaining the required slope.

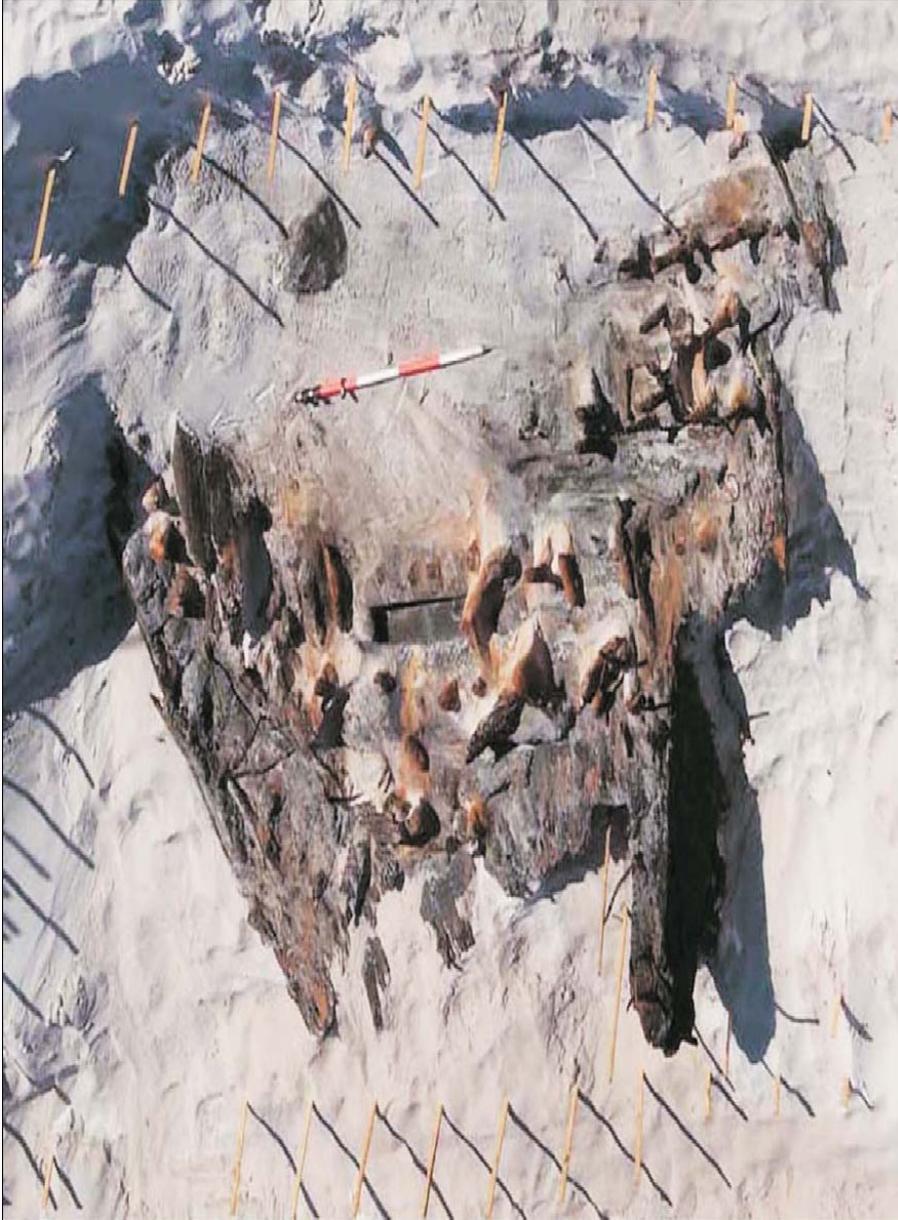
Photograph from "Phase II Historical and Archaeological Investigations of a Shipwreck Site (8ES2940), ARSS Training Site, NAS Pensacola," New South Associates, September 1, 2006.

“...The exposed vessel section represents a portion of the bow and includes the stem, parts of the starboard hull, hull sheathing, and framing. Although the ship’s identity and chronology were not conclusively determined during this project, construction elements, along with artifacts recovered from the site and archival sources, suggest possible dates.

Remains of the ship were inconclusive as to chronology. The excavated bow section exhibited extensive use of iron bolts to attach the hull, frames, riders, and ceiling. If the ship dated to the 1550s de Luna expedition, then it would be expected to include mostly wooden fastenings. The finding of extensive metal fasteners thus suggested an eighteenth-century or later date, which would be more consistent with the 1719 naval battle. On the other hand, instances of the iron fasteners have been found on ships of the 1500s, such as the 1554 wreck of the *San Esteban* (Smith 1993:80). At this point in the analysis of 8ES2940, it is unclear if the use of metal fasteners provides clear information about chronology.

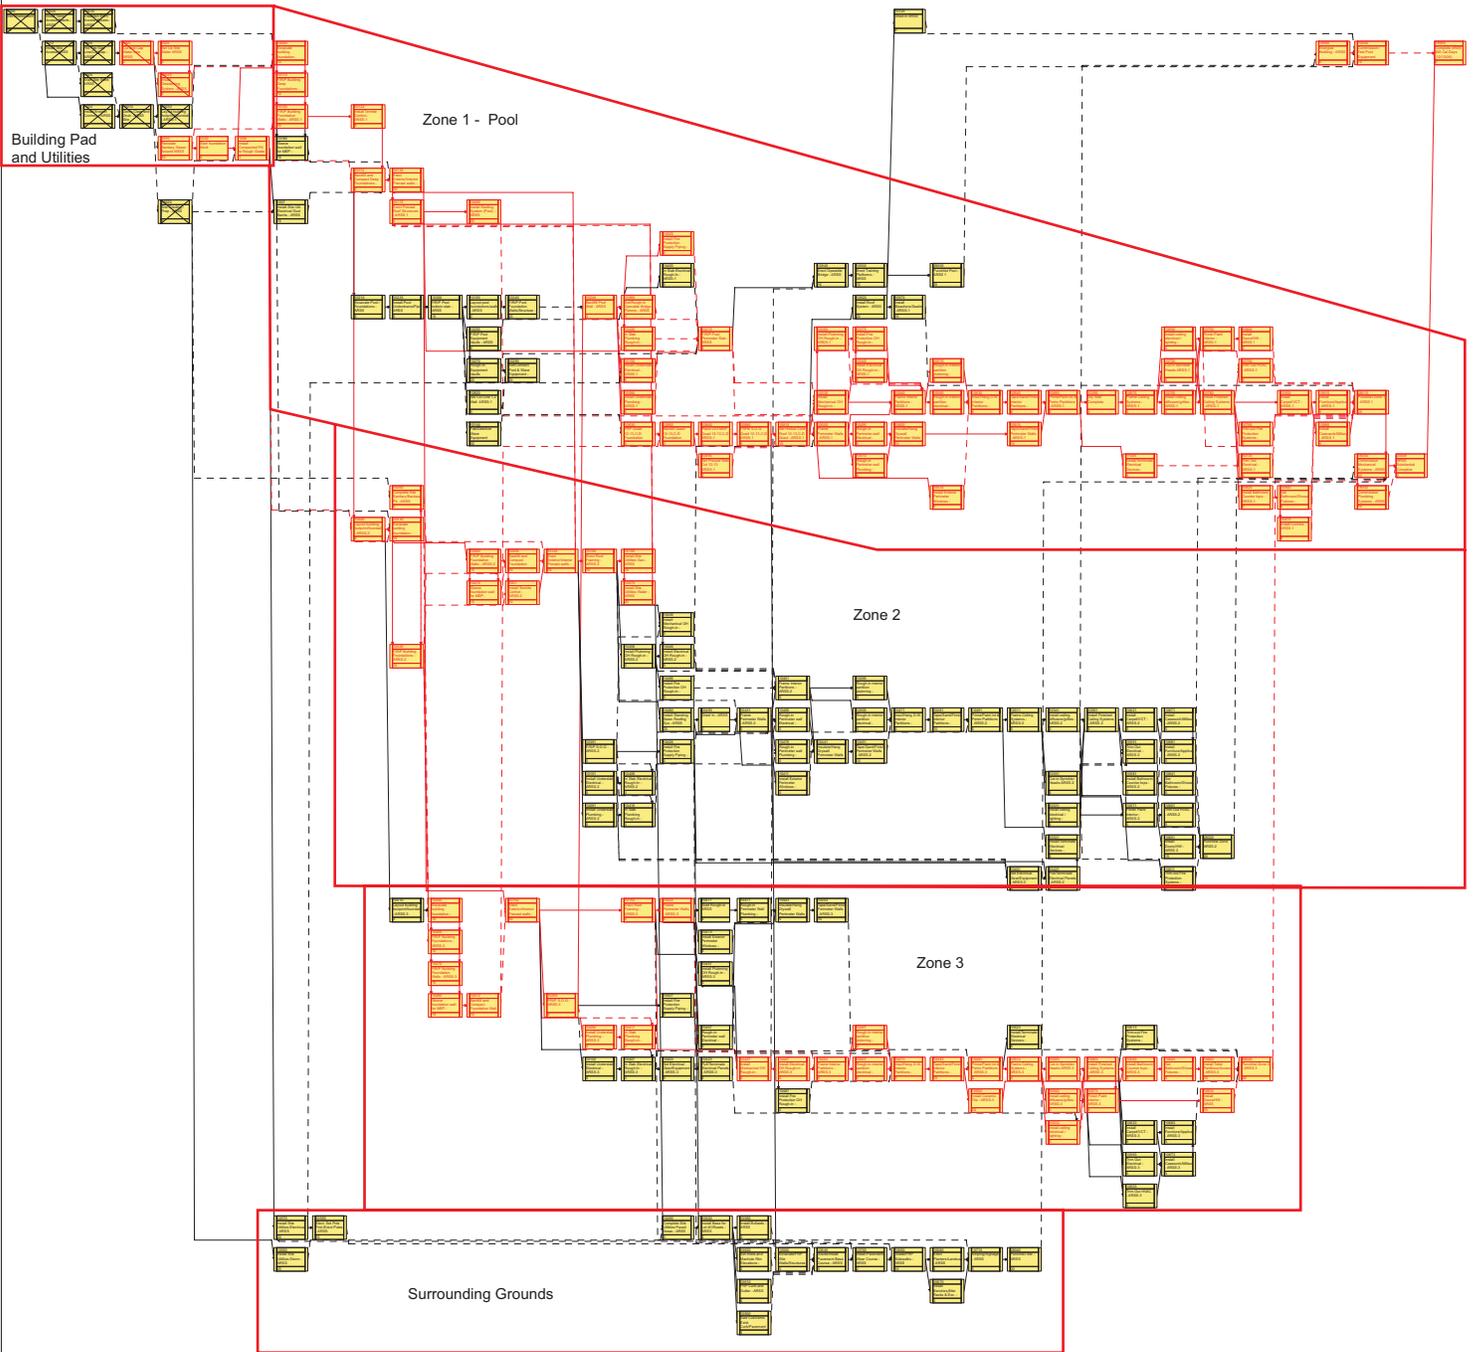
Zone 1 - Pool

Site work

Exhibit Nr 1 shows the ARSS portion of the Precedence Diagram. For the benefit of the reader the network which, contains over 200 activities, has the major paths outlined. In the upper left hand corner of the exhibit is the site work necessary to begin placing foundations. This portion of the network includes activities to set up a de-watering system. In this area the close proximity of the bay and the significant hydraulic pressure associated with the superfluous aquifer make effective de-watering a constant companion to all but the shallowest excavations.

The activities associated with the three zones are outlined and labeled in the exhibit. From the network it is readily apparent that the zones can proceed more or less independently once the pre-cast walls are stood up. The few dependencies that cross between the zones tie together milestones and commissioning efforts. This network is from the February update just prior to encountering the first delays, hence the progressed activities in the Site Work region of the network.

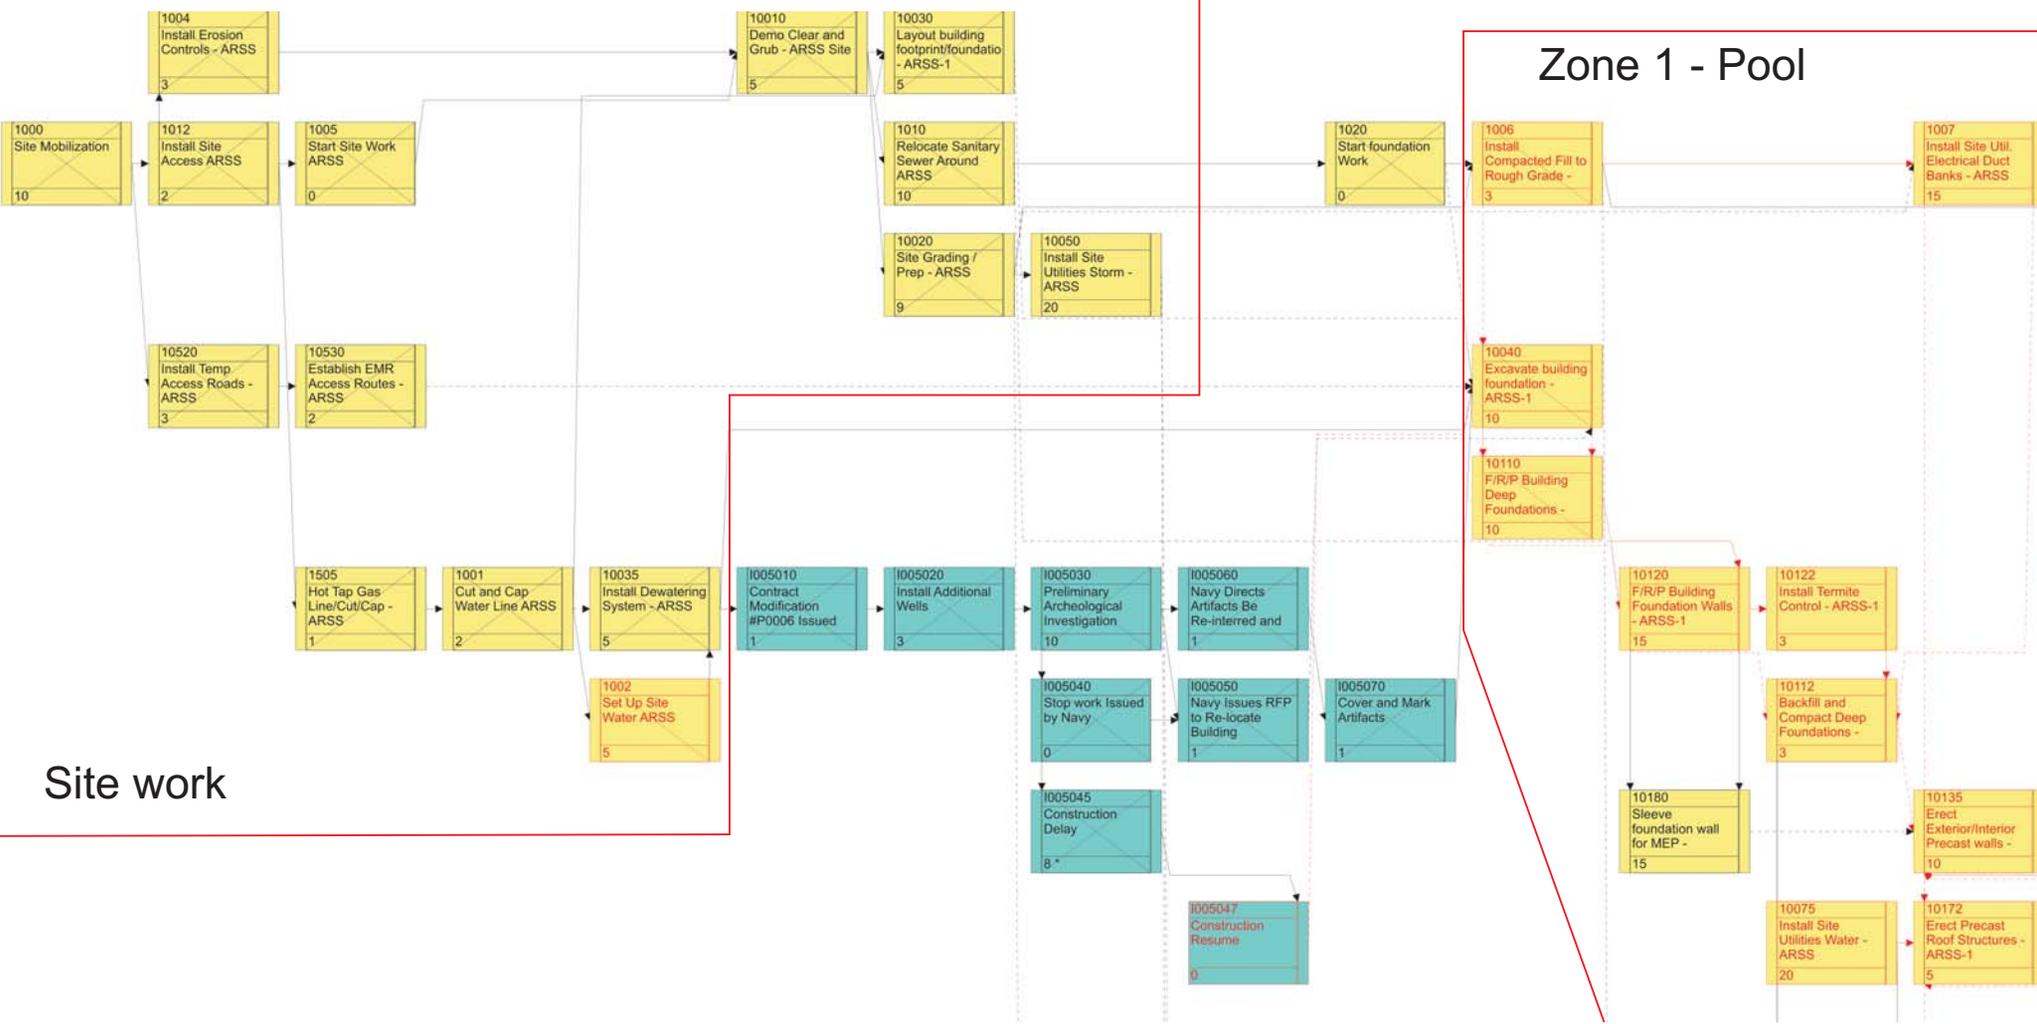
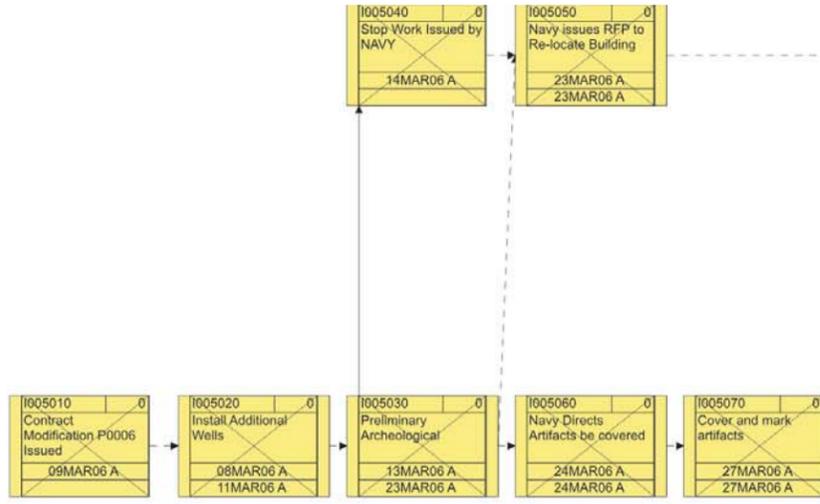
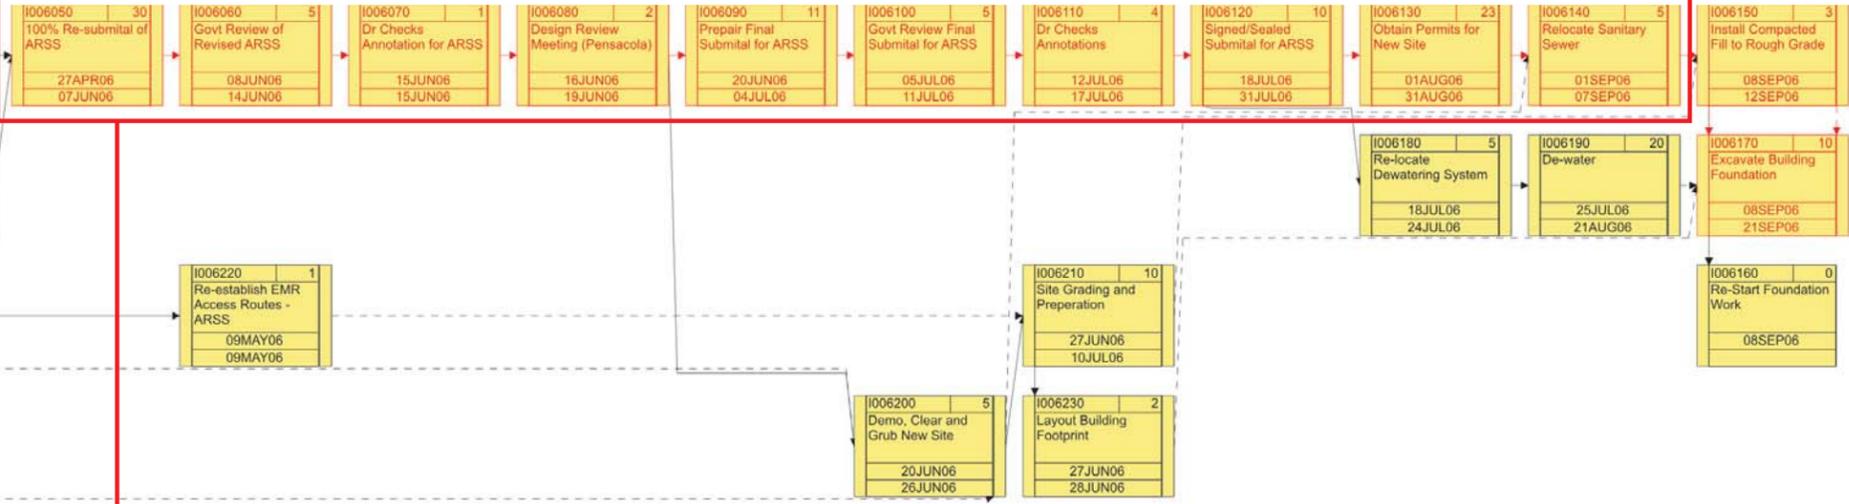
Original Fragnet for P0006

Re-Design

Replacement Activities

defined and could be tracked. Exhibit #3 is the completed fragnet prior to insertion in to the master schedule. The progressed original fragnet was used to anchor the left hand side of the network and allow the computing of reliable dates using the forward pass algorithm. Outside the original fragnet are six progressed activities. A group of four activities represent the effort associated with performing and reviewing the engineering analysis that would determine the new site, and the effort to prepare and approve the proposal to re-locate (I005080, I005090, I006010 and I006020).

Once the new location was identified it became readily apparent that started construction activities that had not yet been completed, and some that had, would have to be abandoned. These activities were annotated with the letters "ABN" in the master schedule. For each one of these activities a new activity was created in the fragnet with an Activity Identification beginning with "I006" to differentiate them from the abandoned duplicates. These activities are outlined in the box in Exhibit #3 named "Replacement Activities"

Once the negotiations were complete the new portions of the fragnet in Exhibit #3 could be inserted in the master schedule and replace the hammock activity previously described. The dependencies from the original fragnet to new activities would be replicated as in exhibit #3. Replacement activities would take on the corresponding successors of the abandoned activities. The abandoned activities successors were replaced with ties to activity I006025, "NAVY - NTP With Re-location of Building," as a housekeeping measure and to stay in compliance with the Navy specification.

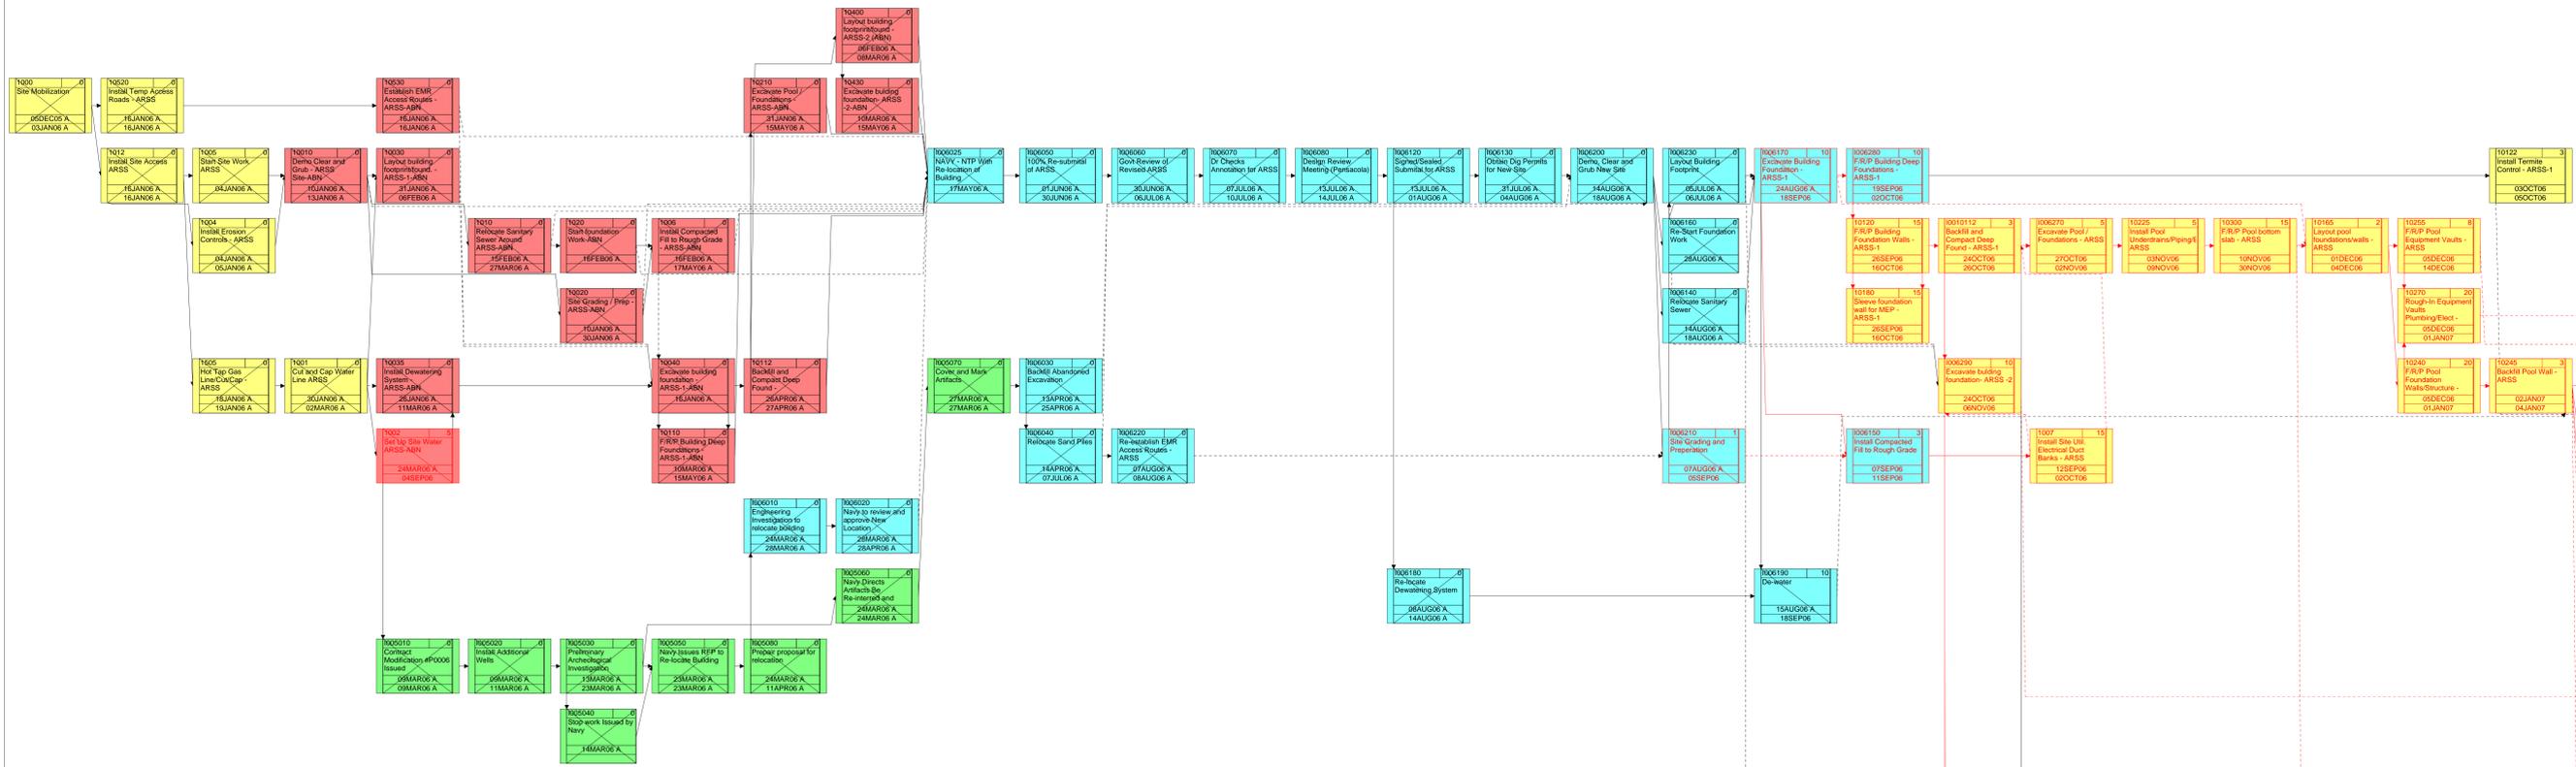
Start date 01MAY06
 Finish date 23JUL07
 Data date 29AUG06
 Run date 19OCT06
 Page number 1A

Exhibit #4 is a portion of the PDM from the September Schedule Update, which actually reflects progress through the end of August. Elements of the fragnets demonstrate the delay are highlighted in colors contrasting with Primavera Project Planner's[®] trademark yellow boxes. Working from left to right we can see only a handful of activities were not impacted by the discovery of the wreck. The original fragnet showing the actions resulting from the issuance of change order #P0006 are highlighted in green. This change modified the Contract Delivery Date changing it from 13 December 2006 to 23 December of the same year. The light blue activity activities are the elements pasted in from the separately developed fragnet. Insertion of the separately developed fragment "strands" a group of affected activities that cannot be completed or must be "re-done". These activities are highlighted in red. These activities were annotated with the letters (ABN) as previously discussed.
